ORIGINAL ARTICLE

Safety of Face Masks and Hygiene Precautions in MRI During Covid-19 Pandemic

Malaysian Journal of Medicine and Health Sciences (2025) 21(4): 239-244. doi:10.47836/mjmhs.21.4.30

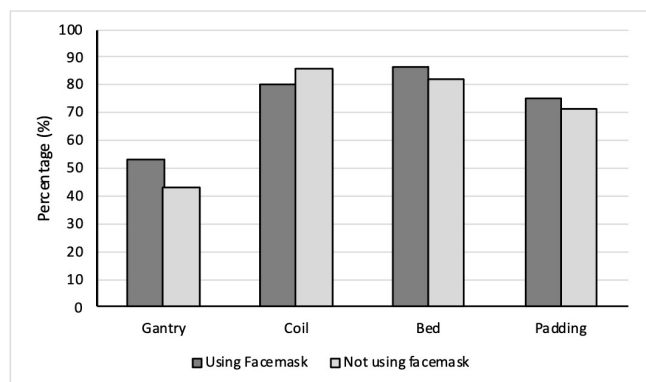
Figure 3: Components of MRI machine sanitised after each scanning of non-Covid patients.

Fig. 3 shows the parts of the MRI machine sanitised after each procedure. The bed and RF coils were sanitised in most institutions regardless whether the patients wore a face mask. While, the gantry was the least sanitised part in both cases. In general, more institutions sanitised their MRI machines when patients did not wear face masks, except for the RF coil.
